SR 363/S. Adams Street

From SR 61/Paul Russell Road to SR 373/Orange Avenue Leon County

Safety Study: Arterial

# SR 363/S. Adams Street

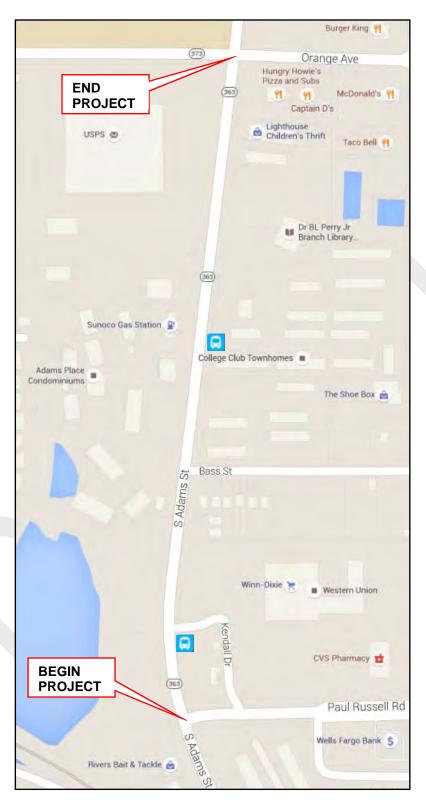
Figure 1 - Project Location

This pedestrian safety study has been conducted on behalf of FDOT District Three Safety Office for the SR 363/S. Adams Street corridor from SR 61/Paul Russell Road to SR 373/Orange Avenue in Tallahassee. The study was initiated based on concerns from the Capital Region Transportation Planning Agency (CRTPA). A Project Location Map, Figure 1, is included on page 3.

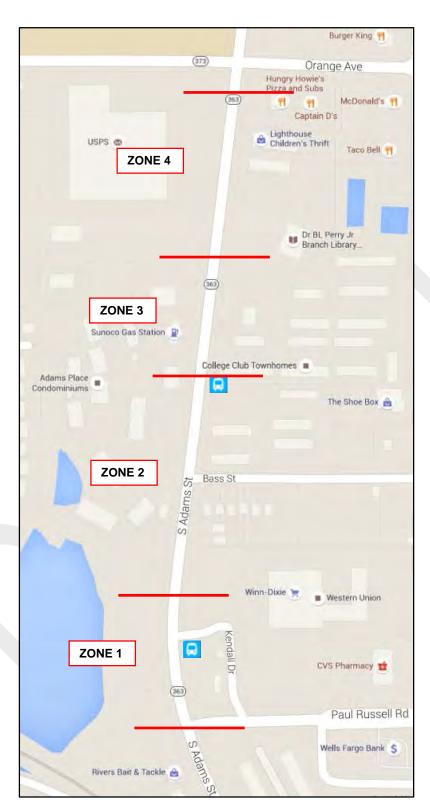
Figure 2 – Pedestrian Count Sections

The detailed counts of the SR 363/S. Adams Street crossings were consolidated into four zones as shown in Figure 2 and the data is summarized in Table 1 below:

The data indicated there were no crossings at the crosswalk on SR 363/S. Adams Street at SR 61/Paul Russell Road and 18 crossings occurred at the SR 373/Orange Avenue south leg crosswalk during the eight hours counted. The detailed pedestrian counts are included in Appendix B.

Zone 1 crossings, near the bus stop at the South Monroe Commons shopping center, were low throughout the 8-hour count period with zero and two pedestrians crossing per hour. Zone 2, the section south of the pedestrian gate at Adams Place Condominiums, had crossing volumes ranging from zero and 12 per hour with the 12 crossings occurring between 4:00 and 5:00 PM. The highest crossings occurred in the vicinity of Zone 3, the College Club Townhomes bus stop. The hourly volumes were between 11 and 41 with the highest occurring between 9:00 and 10:00 AM with 66 percent crossing from west to east. Between 4:00 and 5:00 PM the directional split near the bus stop reversed with 63 percent crossing from east to west. Zone 4, located from the library and post office driveways to SR 373/Orange Avenue, had crossing volumes between zero and 13 per hour with the highest occurring between 11:00 AM and noon.

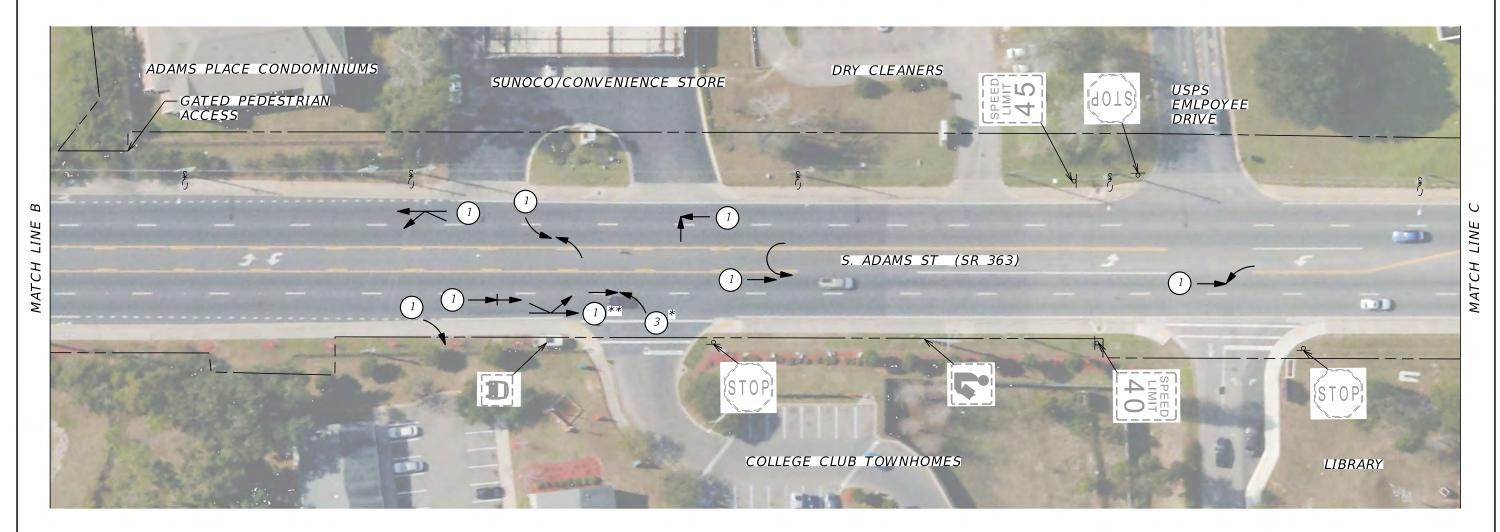
Three of the crashes occurred near the bus stop located at 2833 S. Adams Street which is at the College Club Townhomes driveway. Two crashes occurred as the pedestrian tried to cross SR 363/S. Adams Street and one occurred when the pedestrian was crossing the driveway to the Townhomes. There was also one crash at the Post Office driveway located at 2800 S. Adams Street. This crash involved a southbound pedestrian and an eastbound motorist. The one crash at the signal occurred when a northbound right-turn motorist failed to yield to a pedestrian traveling from east to west in the signalized crosswalk across the south leg. The pedestrians ranged in age from 19 to 50 and three of the five drivers involved in the crashes were between 20 and 22 years old. The crashes occurred during the AM, mid-day and evening hours.

- \* ALL 3 CRASHES OCCURRED WHEN A BUS WAS \*\* MOTORIST STRUCK BUS

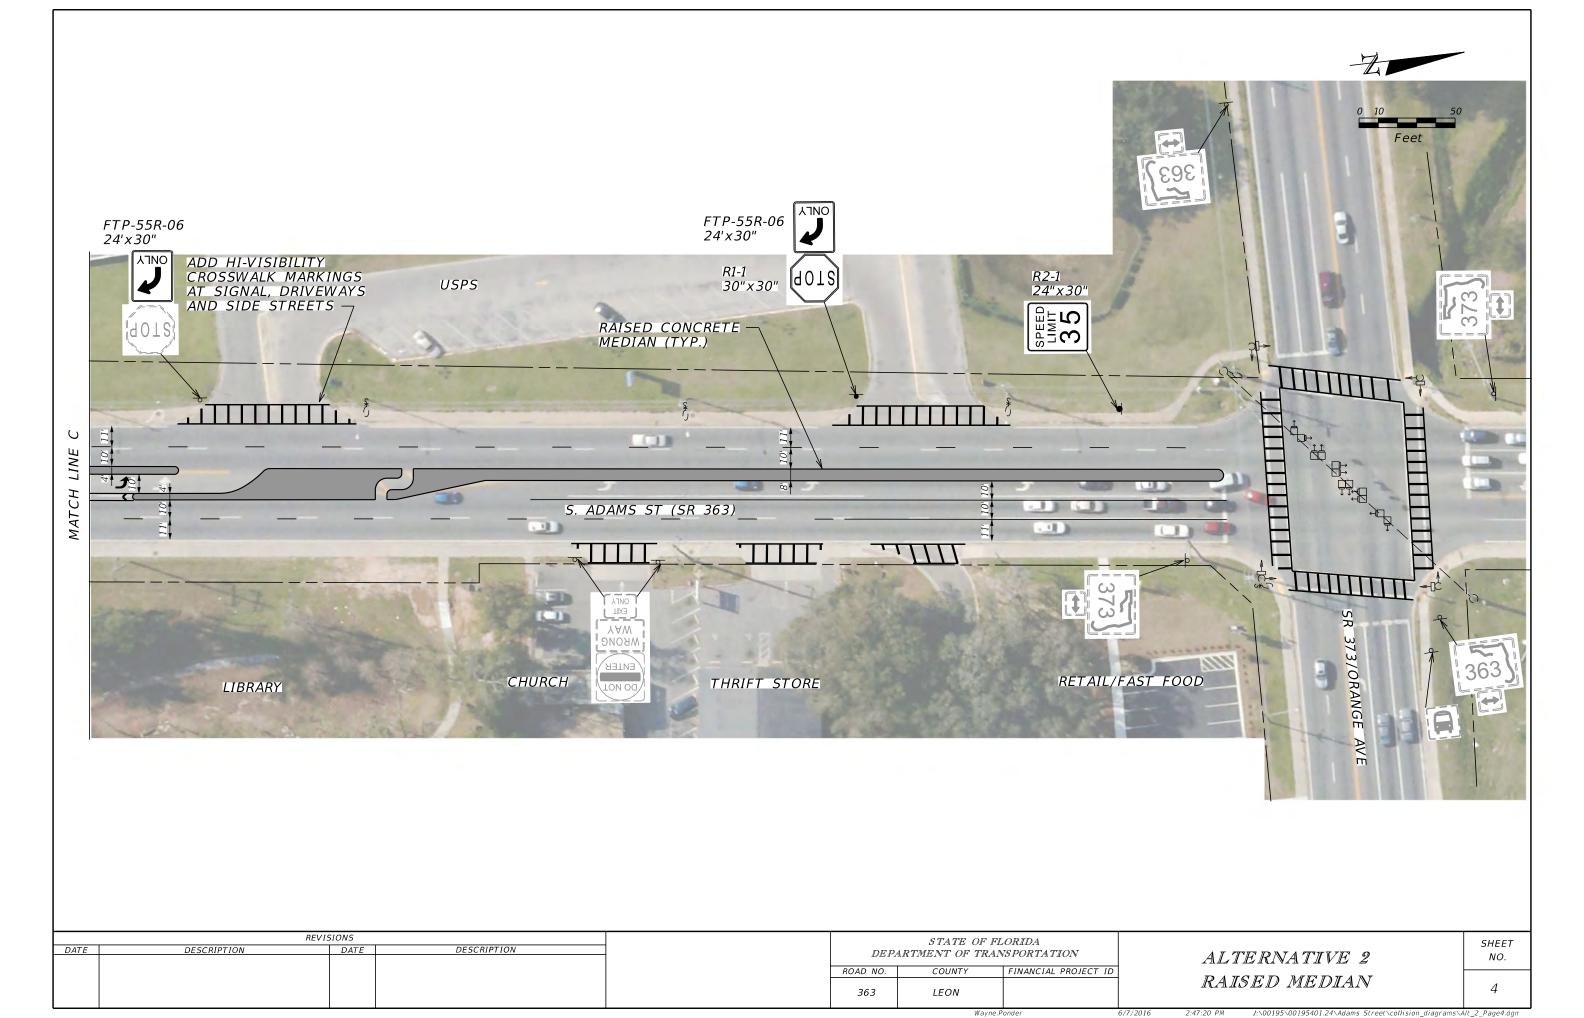
- Missing back plates at SR 363/S. Adams Street and SR 373/Orange Avenue intersection Retroreflective yellow back plates on all signals can improve the signal head visibility during both day and night conditions.

Although not the primary focus of this study, the SR 363/S. Adams Street at Orange Avenue signalized intersection would experience a significant reduction in vehicle crashes with the upgrade of the signal to current standards including replacing the diagonal span wire with mast arms, yellow retroreflective back plates, one signal head per through lane, 5-section signals replaced with 4-section flashing yellow arrow signals and illuminated street name signs to name a few. Although the Paul Russell Road signal heads are on mast arms, the intersection is in need of similar standard upgrades to improve the signal head visibility.

- \*\*\* - REPLACE 5-SECTION SIGNAL HEADS WITH 4-SECTION FYA - PROVIDE ONE SIGNAL HEAD PER LANE

- ADD RETRO-REFLECTIVE BACK PLATES FOR ALL SIGNAL HEADS RELOCATE PED PUSHBUTTONS TO CORRECT SIDE OF POLE/PEDESTAL RELOCATE PED SIGNS TO THE CORRECT SIDE OF POLE/PEDESTAL
