AGENDA ITEM 6 C

THOMASVILLE ROAD SAFETY DISCUSSION

SR 61 / Thomasville Road Supplemental Safety Study

*Gadsden Street to Betton Road /
Bradford Road Corridor*

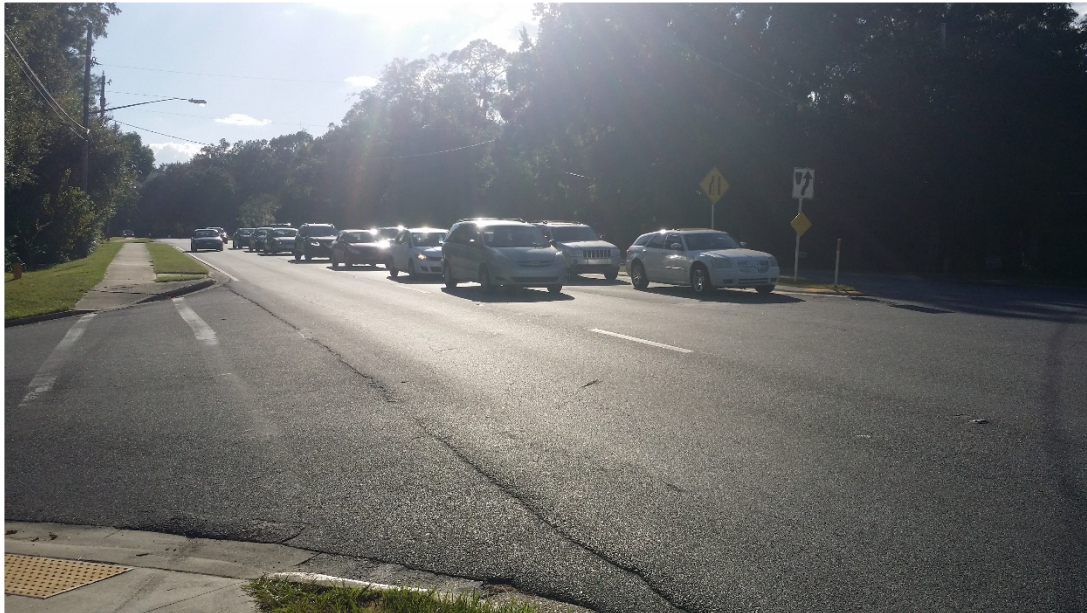
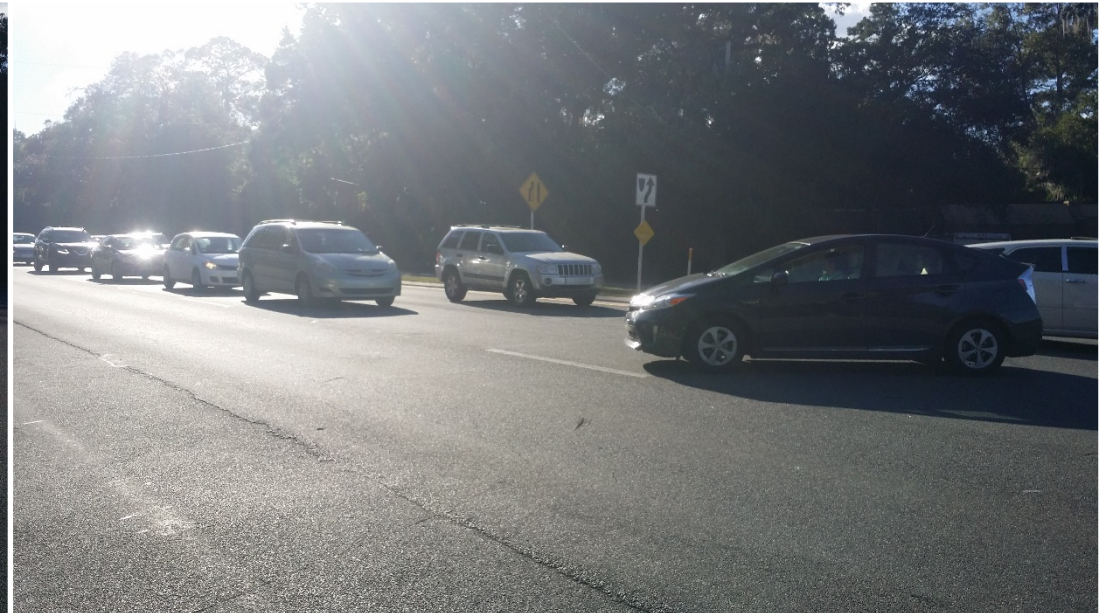
- > Five-Year Crash Investigation (2010-2015)
 - Left-turn Crash Pattern
 - Colonial Drive to Collins Drive
 - Weekday / PM peak hours / local motorists
